Cypress, TX 77429

August 22, 2025

PROPERTY INSPECTION REPORT FORM

Name of Client	08/22/2025
Cypress, TX 77429	Date of Inspection
Address of Inspected Property	
ANH PHAM	26748
Name of Inspector	TREC License #
Name of Sponsor (if applicable)	TREC License #

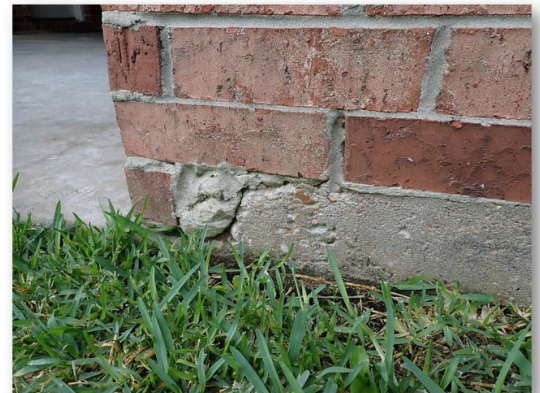
Note: One or more of the foundation perimeter beam corners were observed to be sheared off (corner pop). This is a common condition to observe and is due to thermal expansion and contraction of the different building materials. This condition does not adversely affect the foundation performance. However, in some cases, some cosmetic improvements may be necessary.

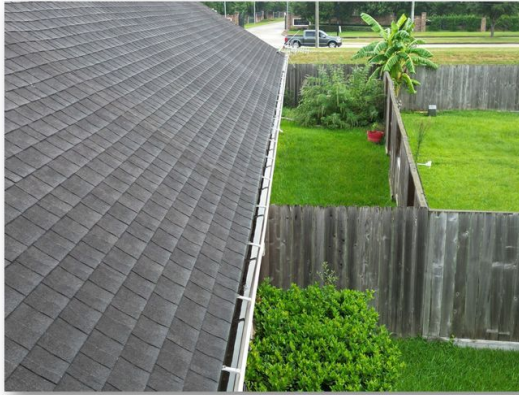
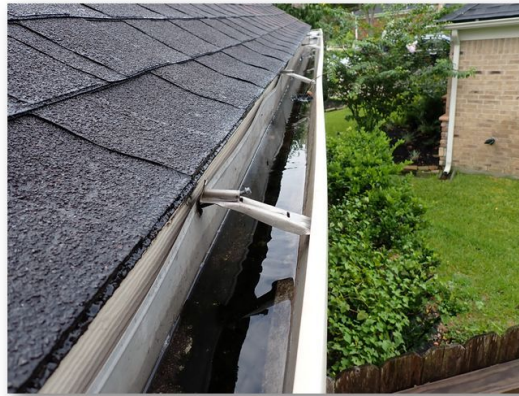
- It is recommended to clean the gutters.
- The gutters do not have sufficient slope to drain properly on the north side, east side, west side of the roof structure. If they do not perform as intended, it is recommended to adjust the slope.
- It is recommended to repair minor leaks in the gutter joints and seams.
- Damaged gutters were observed on the west side, east side of the roof structure.
- One or more of the gutter fasteners were observed to be pulling loose on the west side of the roof structure.
- Some of the gutter is pulling loose on the west side, east side of the roof structure.

The gutter/downspout system needs to be checked, reset or repaired as necessary. The observations made to support the rendering of this opinion are listed but may not be limited to:

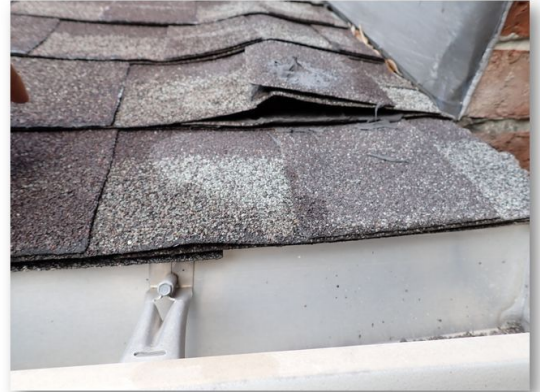
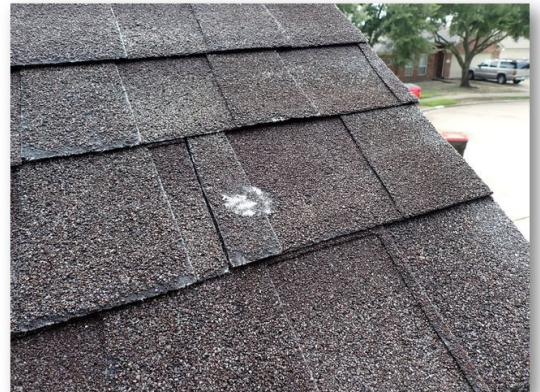
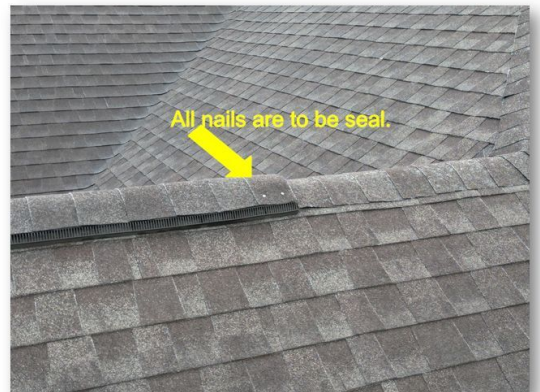
- One or more of the shingles were observed to be lifting on the south side of the roof structure.
- The composition roofing material has experienced granular loss in various locations throughout the roof.
- The fasteners at the satellite dish mount should be sealed to help prevent water leakage at this point.

Note: Some discoloration of the roofing material was observed.

Note: Roof fasteners (nails and/or staples) were observed to be exposed and should be properly sealed at the ridge caps and flashing areas.

You are strongly encouraged to have a properly certified roofing contractor to physically inspect the roof, prior to the expiration of any time limitations such as option or warranty periods, to fully evaluate the condition of the roofing material. The observation made to support the rendering of this opinion are listed but not limited to the following:

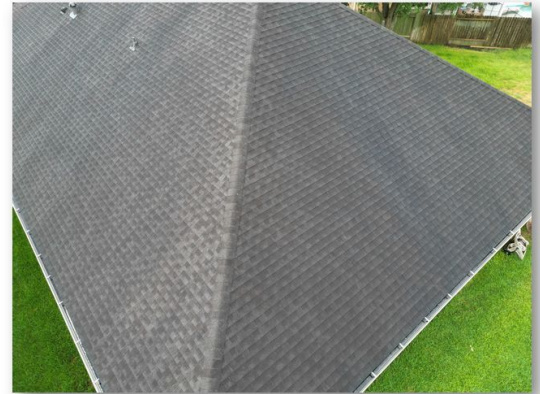
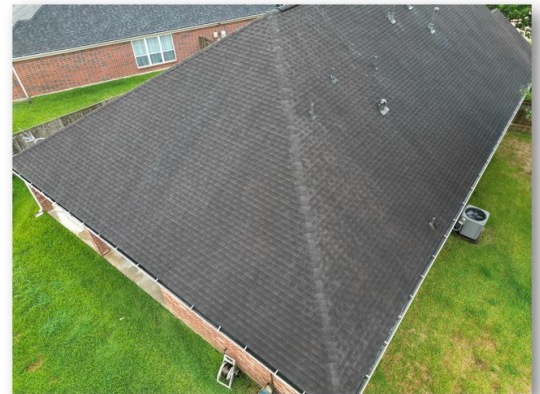
Flashing Details

- The flashing is lifting and/or pulling loose on the south side of the roof structure. This condition could allow water intrusion at this location.
- It is recommended to properly seal the storm collar(s) at the roof level gas equipment vent pipe(s) to help prevent water intrusion into the structure.
- It is recommended to seal one or more of the plumbing vent stack rubber boots to prevent water intrusion at this location.

Note: There is no rain diverter in place at the roof line drip edge over the outside condenser / coils of the HVAC system. It is recommended to install a rain diverter to help divert rain water from falling into the outside condenser / coils.

You are strongly encouraged to have a properly certified roofing contractor to physically inspect the roof, prior to the expiration of any time limitations such as option or warranty periods, to fully evaluate the condition of the roofing material. The observation made to support the rendering of this opinion are listed but not limited to the following:

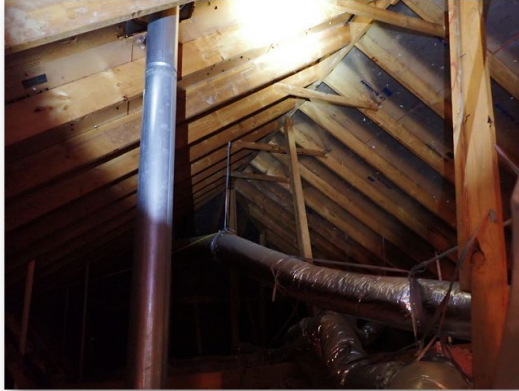
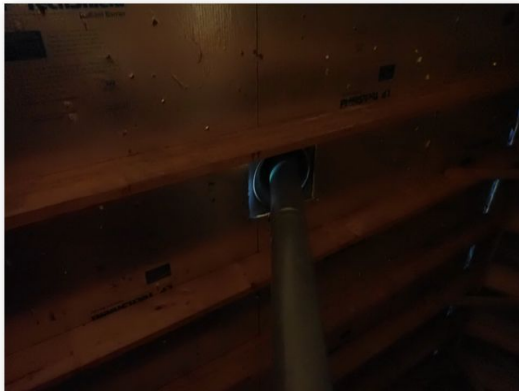
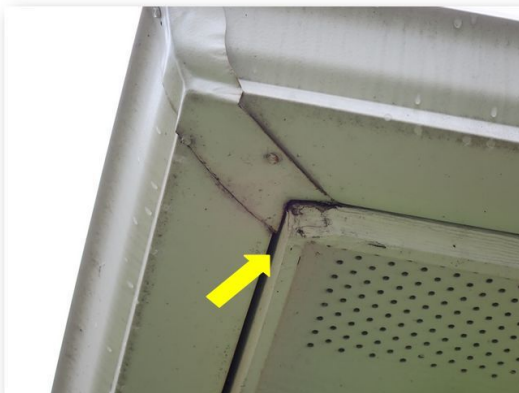
- It is recommended to seal all openings between the soffit and roof covering to prevent pest/rodent intrusion at this point.
- The fascia/frieze board material has some deterioration and/or damage on the north side, south side, east side, west side of the roof structure.

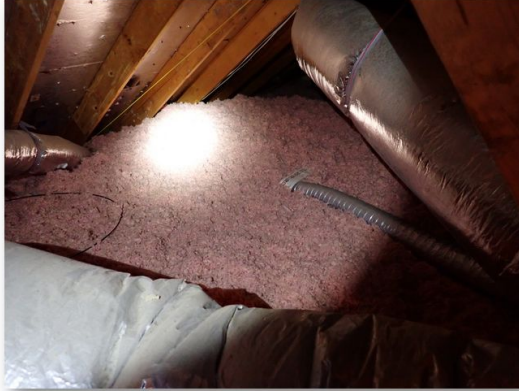
- The attic floor insulation should be redistributed in one or more locations.

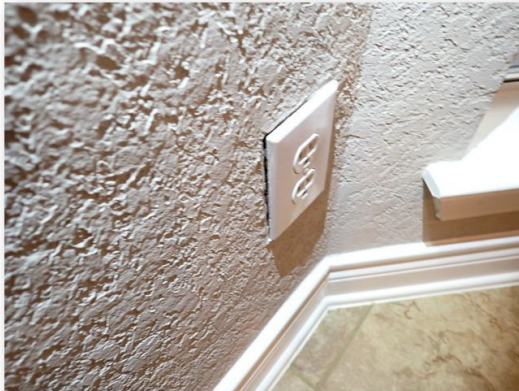
- Paint touch ups are recommended in several locations at the time of inspection.
- Interior wall joint cracks were observed in the several locations throughout the house.
- Interior wall stress cracks were observed in the primary bedroom.

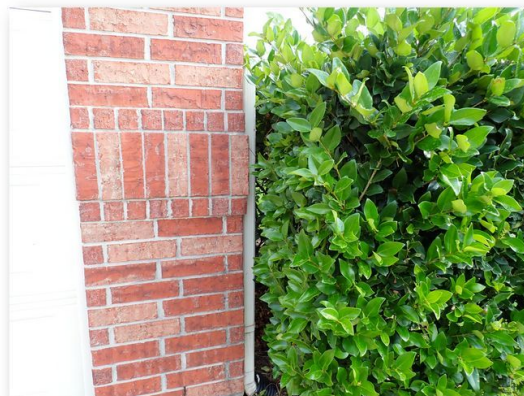
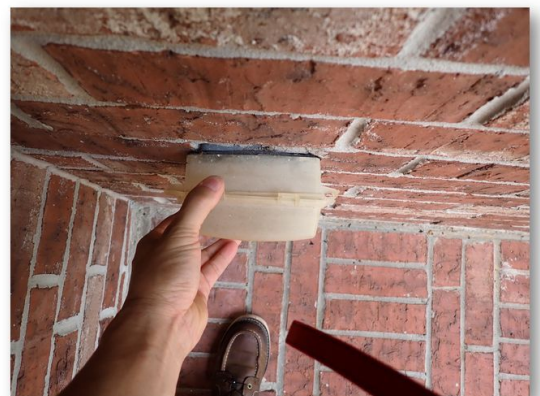
- The area between the exterior cladding / veneer and all of the wall penetrations / openings should be properly sealed. Areas such as utility connections, downspouts, hose bibbs, lighting fixtures, receptacles, vent termination covers, etc. It is recommended to use an elastomeric sealant.
- All joints between two different types of siding should be properly sealed. It is recommended to use elastomeric sealant.
- Caulking improvements are recommended for the area between the exterior veneer and the window frames. It is recommended to use an elastomeric sealant.
- All joints between two different types of siding should be properly sealed. It is recommended to use elastomeric sealant.
- Mortar improvements are recommended for the exterior masonry veneer on the south side of the structure.
- It is recommended to add a fresh coat of exterior paint where needed to the exterior veneer.

Note: Mortar and/or brick cracks were observed in the exterior veneer on the south side of the structure.

Note: The heavy foliage growing on, over or around the exterior walls of the structure should be trimmed back at least 18-inches. The heavy foliage will limit the inspectors visual observation of the exterior surfaces.

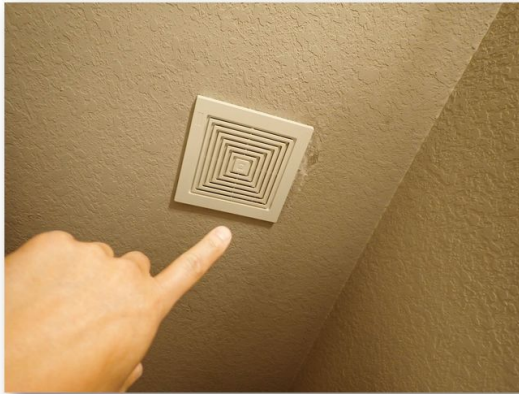
- Paint touch ups are recommended in several locations at the time of inspection.
- Ceiling joint cracks were observed in the primary bedroom.

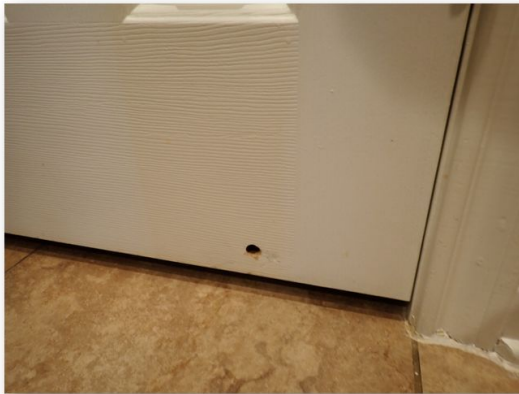
Interior Doors

- Paint touch ups are recommended in several locations at the time of inspection.
- Surface damage was observed to the door in the kitchen.

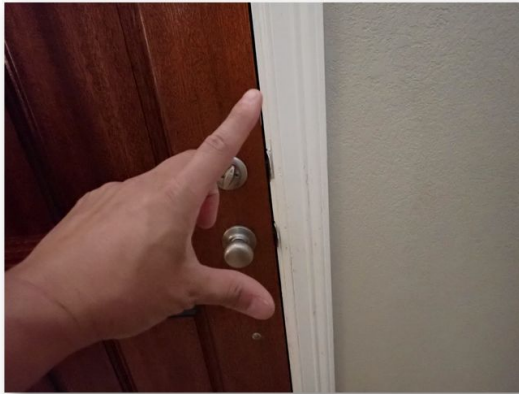
Exterior Doors

- Weather-stripping improvements are recommended for the front entry exterior door(s).

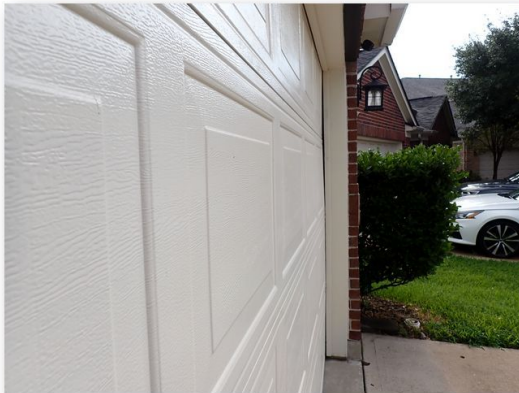
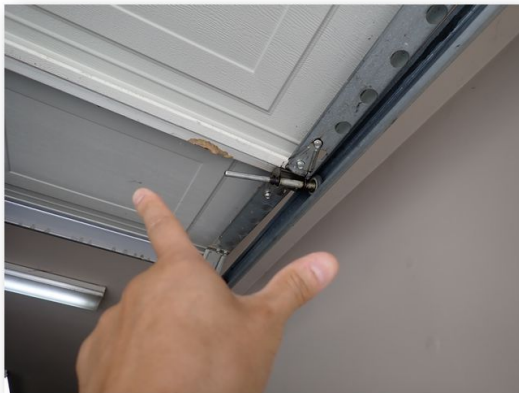
Overhead Garage Door

- The overhead garage door window glass is missing.
- Some damage to the overhead garage door was observed.

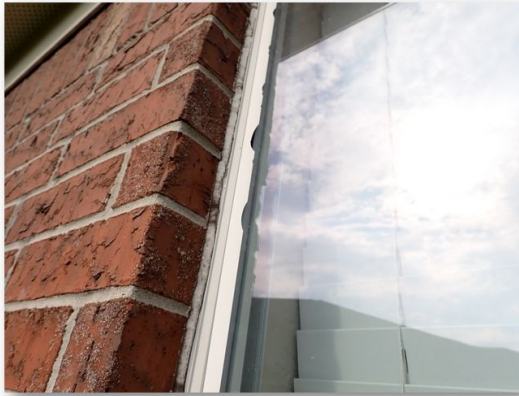
- One or more of the window screens were observed to be damaged.

- One or more of the thermal pane windows were observed to have lost their seals. This has resulted in condensation or a fog like film to develop between the panes of glass. The thermal pane windows no longer function as designed when they lose their seal and replacement may be necessary. The windows that have noticeably lost their seals are listed but may not be limited to the following: breakfast area; living room; primary bedroom.

- The window weather-stripping is damaged and/or missing at one or more of the windows and improvements are recommended.
- The window sash guide is damaged in the several locations throughout the house.
- One or more of the windows are stiff and hard to operate in the several locations throughout the house.

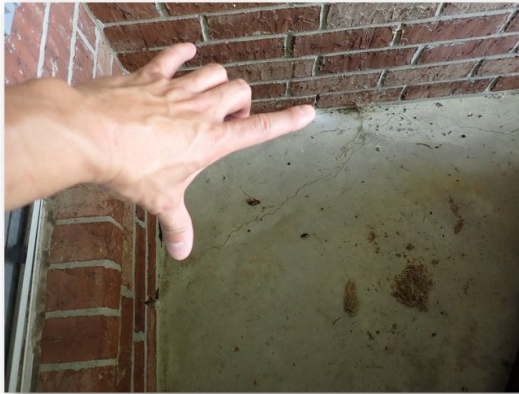
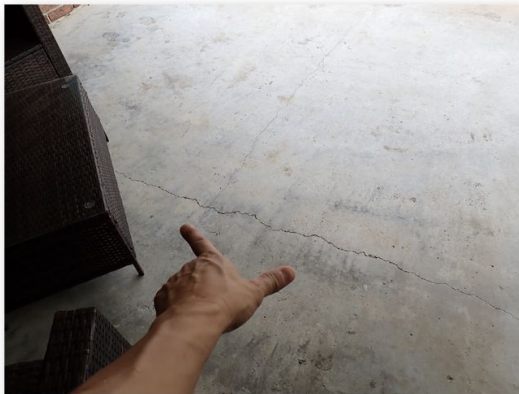
- Minor cracks and/or deficiencies were observed in the patio.

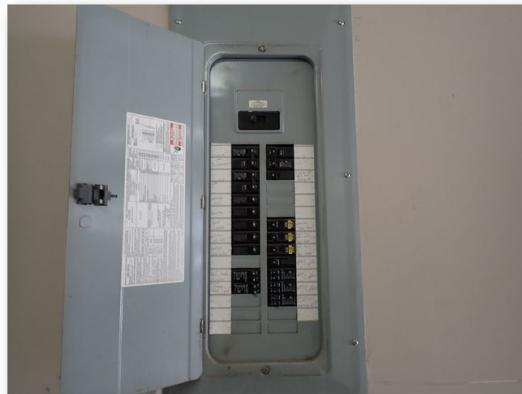
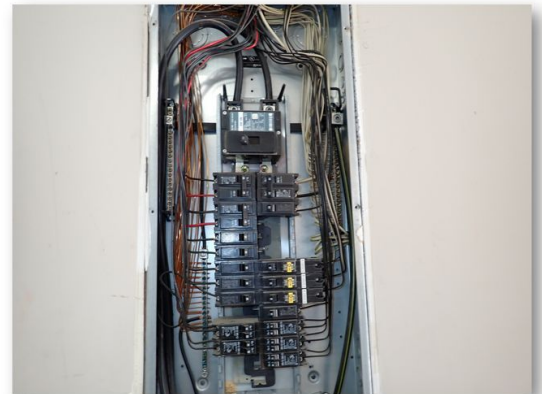
Arc-Fault Circuit Interrupter Protection (AFCI)

- Not all of the required dwelling unit devices, receptacle and lighting outlets (switches, receptacles and fixtures) are connected to an arc-fault circuit-interrupter (AFCI) circuit device. AFCI devices were first required under the 1999 National Electrical Code and under the 2014 NEC, all living space, kitchen and laundry room devices, receptacle and lighting outlets (switches, receptacles and fixtures) should be connected to an arc-fault circuit interrupter (AFCI) device.

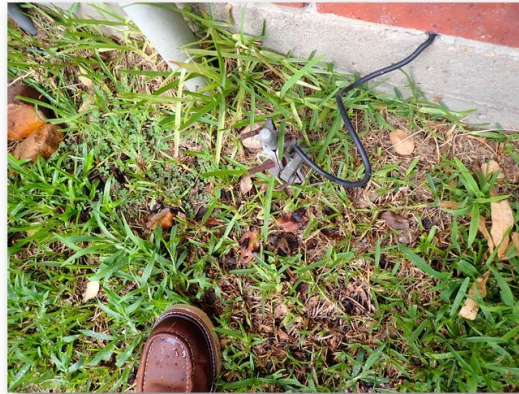
- The grounding electrode clamp is loose at the ground rod. It is recommended to tighten the clamp.

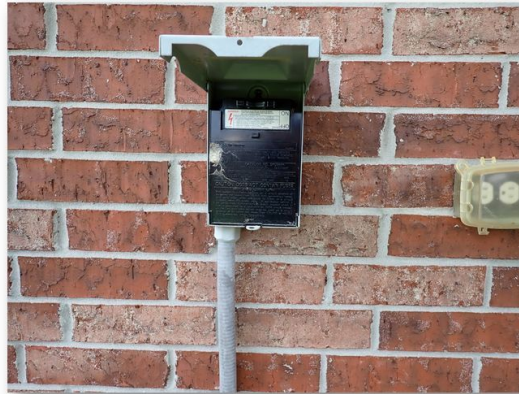
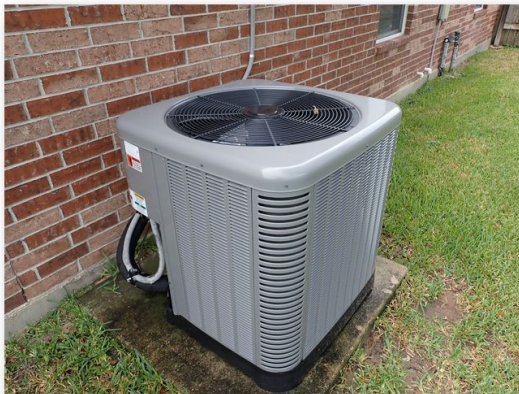
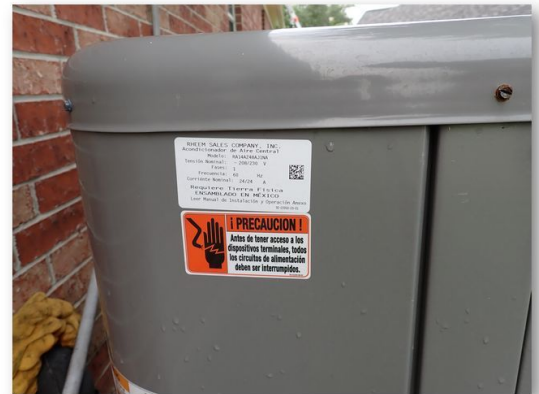
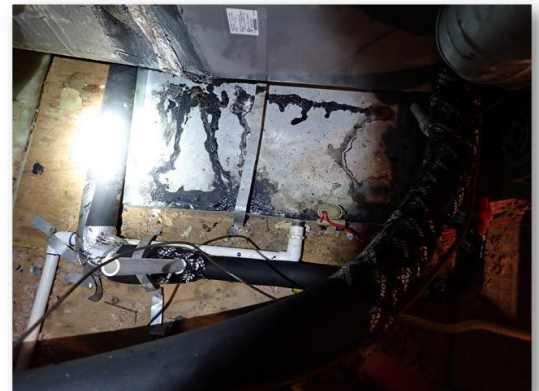
- The dirty air filter should be replaced.
- There was an unknown mold like substance observed on the outer surface of the HVAC system. Evaluation of this substance is beyond the scope of this inspection. If any concerns exist on the type and/or nature of this substance, we recommend further evaluation by a professional in the Air Quality sampling field.
- Condensate was observed around indoor unit at time of inspection

Note: The auxiliary/secondary drain pan under the coil housing has some water staining and/or a rust build-up. This would indicate that the pan has held water in the past and should be closely monitored.

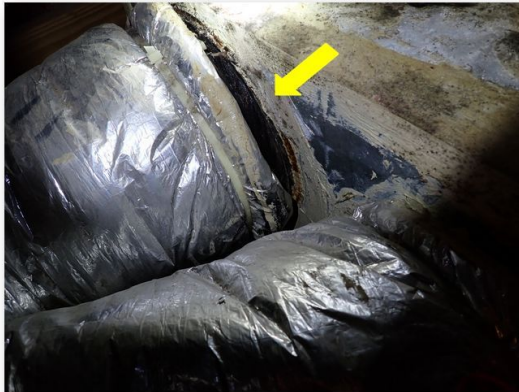
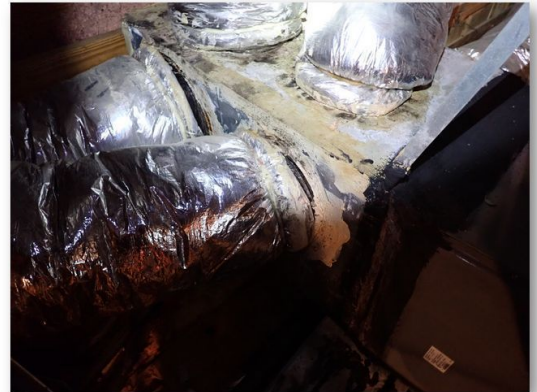
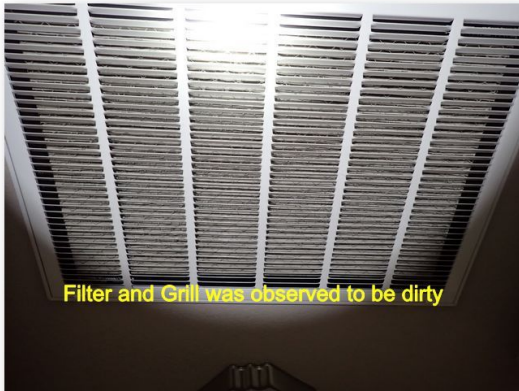
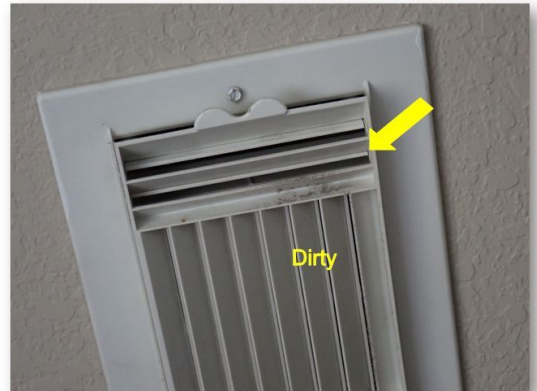
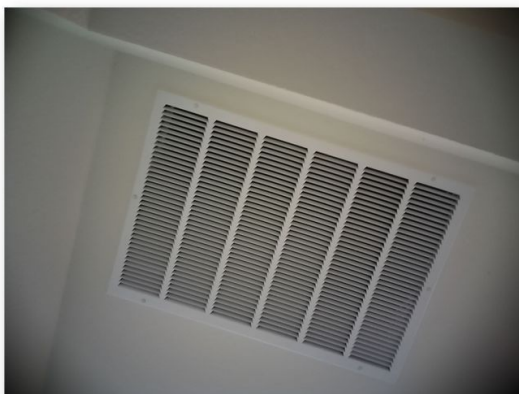
- Ductwork insulated covering was observed to be damaged and/or pulling loose.
- There was an unknown mold like substance observed on the outer surface of the duct work. Evaluation of this substance is beyond the scope of this inspection. If any concerns exist on the type and/or nature of this substance, we recommend further evaluation by a professional in the Air Quality sampling field.
- Air leaks were detected at and around the ductwork connections and the distribution plenum(s).
- The air-return chase for the HVAC system is dirty and should be cleaned to help maintain good air quality.

Additional Notice from the Inspector: The ductwork was observed to be older and in poor condition. It is recommended to replace the ductwork for improved air quality and efficiency.

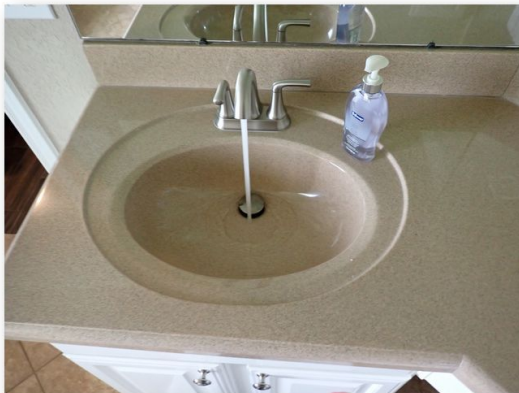
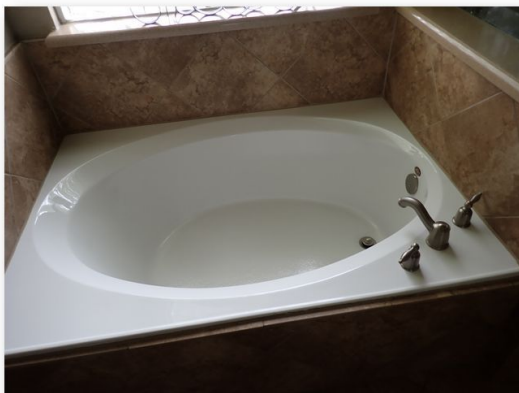
Shower

- Cracked, deteriorated and/or missing grout and/or caulking should be repaired or replaced as necessary.

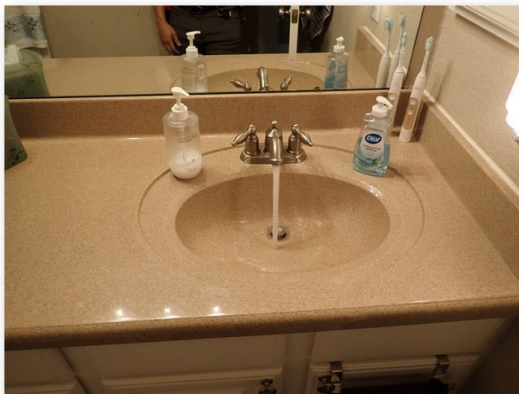
Bathtub

- Cracked, deteriorated and/or missing grout and/or caulking should be repaired or replaced as necessary.
- The tub spout is not properly sealed at the wall. This condition has the potential to allow water to leak back into the wall cavity.

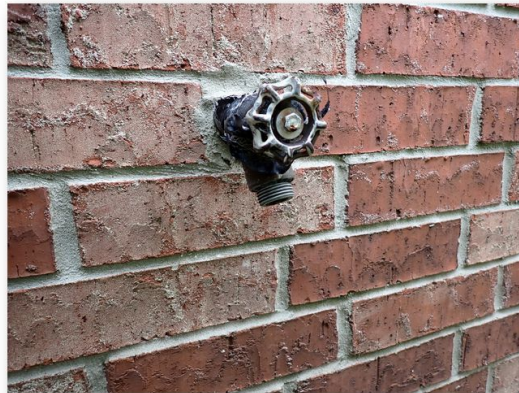
Exterior Faucets/Fixtures

- The exterior water hose bib (faucet) is inoperative on the west side of the structure.

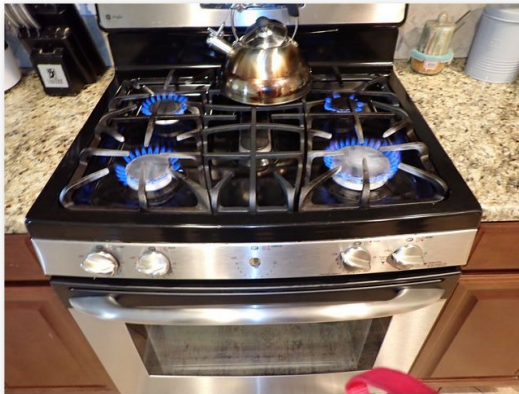
D. Ranges, Cooktops, and Ovens

- One or more of the control knobs are damaged.
